**Flood Control Project Maintenance
Levee Inspections**

Fall 2009 Levee Maintenance Deficiency Summary Report

Reclamation District No. 2107

Levee Inspection Report By Mile - Fall 2009

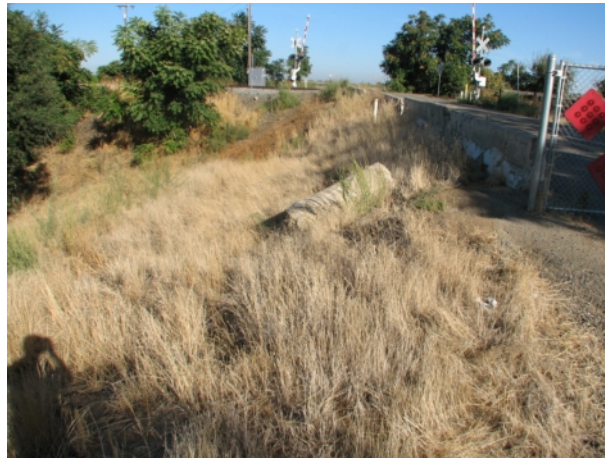
Levee Mile Report Line	2
Start Levee Mile	0.03
End Levee Mile	0.03
Location	Land Side
Category	Earthen Levee
Item	Encroachments

Photo of 4-ft long concrete cylinder on landside levee slope at start of unit 1.

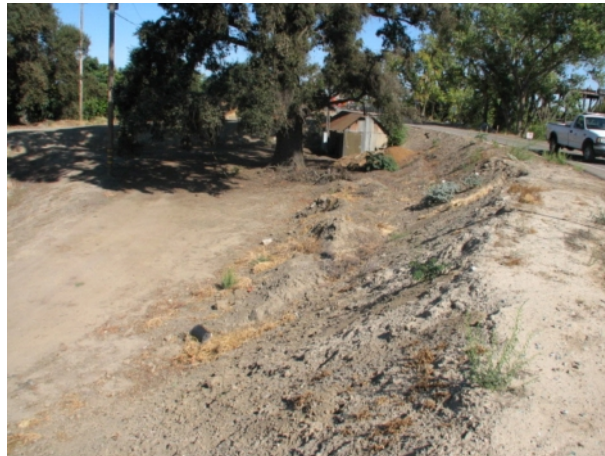
Levee Mile Report Line	3
Start Levee Mile	0.06
End Levee Mile	0.06
Location	Land Side
Category	Earthen Levee
Item	Encroachments

Photo of wood chips placed within 10-ft of landside levee toe.

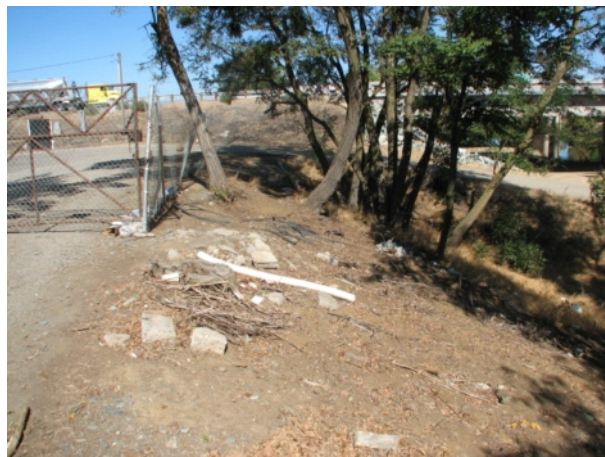
Levee Mile Report Line	4
Start Levee Mile	0.26
End Levee Mile	0.26
Location	Water Side
Category	Earthen Levee
Item	Encroachments

Photo of litter near highway bridge over San Joaquin River.

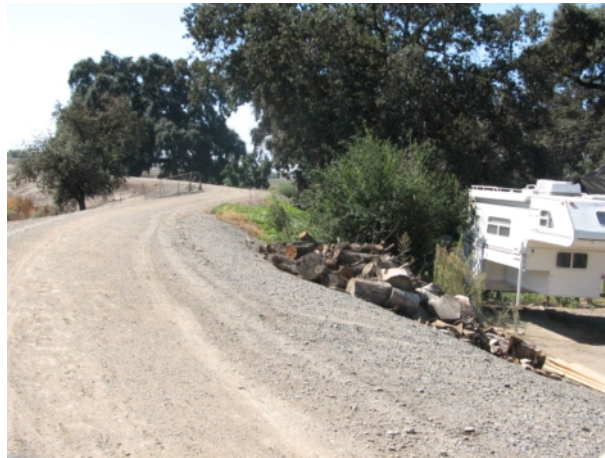
Levee Mile Report Line	5
Start Levee Mile	1.23
End Levee Mile	1.23
Location	Land Side
Category	Earthen Levee
Item	Encroachments

Photo of wood pile on landside levee slope.

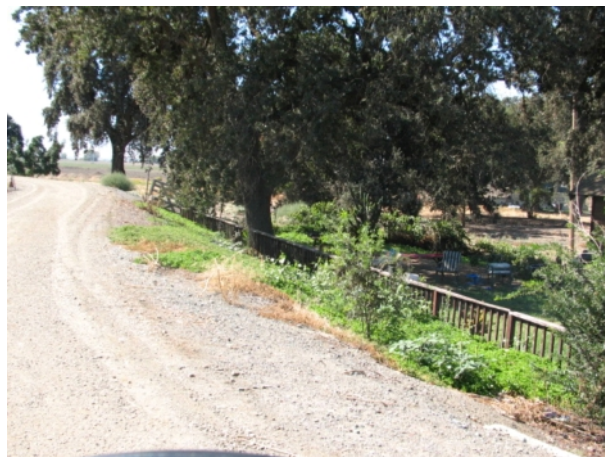
Levee Mile Report Line	6
Start Levee Mile	1.24
End Levee Mile	1.24
Location	Land Side
Category	Earthen Levee
Item	Encroachments

Photo of landscape planting on landside levee slope and a 3-ft yard fence at the levee toe.

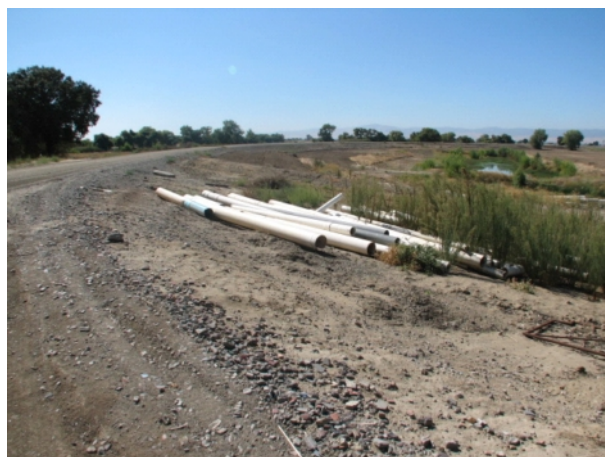
Levee Mile Report Line	7
Start Levee Mile	1.50
End Levee Mile	1.50
Location	Land Side
Category	Earthen Levee
Item	Encroachments

Photo of plastic irrigation pipe on levee slope and within 10-ft of the landside levee toe.

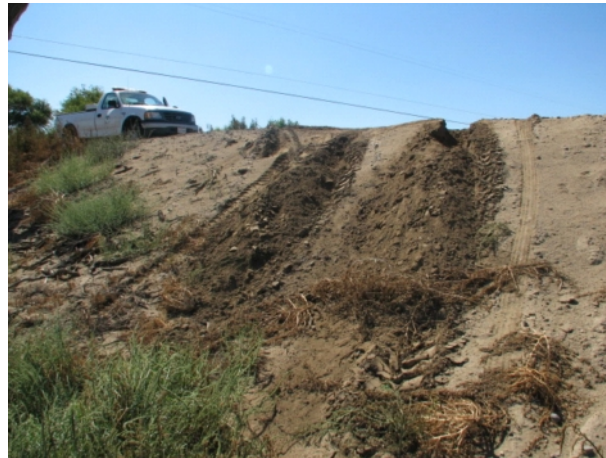
Levee Mile Report Line	3
Start Levee Mile	1.29
End Levee Mile	1.29
Location	Land Side
Category	Earthen Levee
Item	Slope Stability

Photo of wheel ruts on landside levee slope. This should be repaired before coming rains worsen the conditions.
